EXISTING CONDITIONS

This chapter examines various aspects of the College's existing facilities, encompassing the campus context, infrastructure, zoning, buildings, and program. This analysis forms a foundation and guide for development of the Master Plan (presented in Chapter 4) and its underlying growth projections, which are presented in Chapter 3.

The **Master Plan** included an assessment of the buildings shown in the site plan on the facing page. This assessment is based on firsthand observations from a site visit on April 30 and May 1, 2018, combined with review of existing conditions drawings and the University’s Facility Condition Assessment (FCA) reports prepared by ISES Corporation.

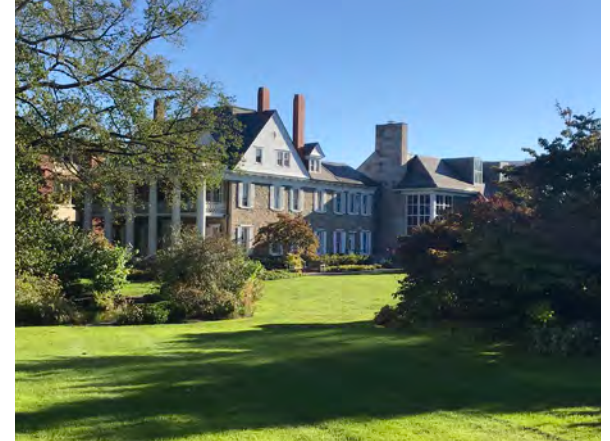
The Master Plan is focused on two precincts within the Penn State campus at University Park. The Core Campus is located west of Old Main and is bounded by College Avenue and Burrowes Road on its south and west sides, respectively, and is contained within the Farmers' High School Historic District. COE buildings within the Core Campus include Sackett, Hammond, the Engineering Units, Reber, Electrical Engineering West, and Electrical Engineering East. The Core Campus has a strong historical connection to the overall Penn State campus with three Charles Klauder designed buildings, the most prominent of which is Sackett, which face Pattee Mall and the Old Main Lawn. Klauder designed many prominent buildings on campus, including Old Main. He is "known for being the creator of background buildings, the warp and tapestry of great American college campuses."* At the center of the Core Campus is one of the oldest buildings on campus, University House, which was home to eleven of the University's presidents and is now part of the Hintz Alumni Center.

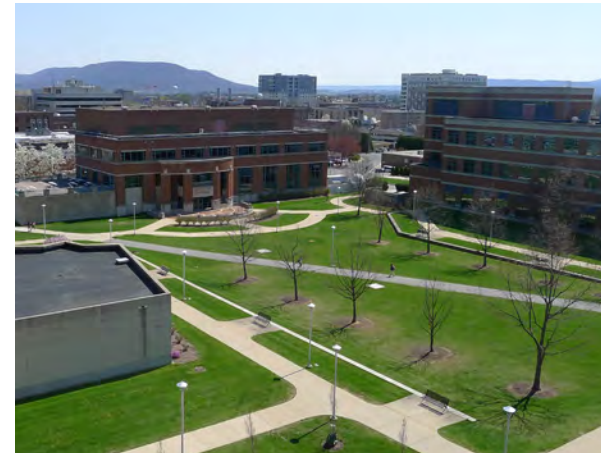
The West Campus is a much newer development, situated to the west of North Atherton Street and bounded by the golf course and playing fields to the north, the White Course Apartments to the west, and Railroad Avenue / Old Railroad Grade to the south.

COE Buildings within West Campus include Earth and Engineering Sciences, Leonhard, Engineering Services, Hallowell, Research West, and Westgate. The College also has some presence in the Applied Sciences Building, which is primarily occupied by the Advanced Research Laboratory (ARL). Westgate, which the College shares with the College of Information Sciences and Technology (IST), was completed in 2004 and serves as a pedestrian bridge over North Atherton, which is part of US Route 322 and a heavily traveled road. Westgate thus serves as a critical link between the West Campus and the rest of the Penn State campus, aligning with Pollock Road, a primary east-west thoroughfare.

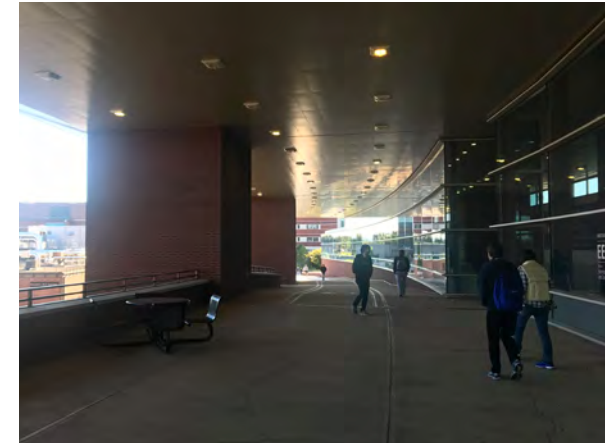
Above: Outdoor Bridge of the Westgate Building, Spanning Atherton Street to Provide Pedestrian Connection to West Campus

As noted above, Westgate provides an important connector to the West Campus for the University community at large. However, for COE students moving back and forth from buildings on the Core Campus, most of which are clustered near College Avenue, the natural desire line to the West Campus is to head west down Steam Drive, between ARL and Walker, and cross Atherton at the crosswalk that leads to the bus depot. COE students seem disinclined to walk up Burrowes Road in order to use the Westgate connector. While there is a traffic signal and crosswalk at the Atherton crossing, the University reports that members of the Penn State community frequently cross against the light which, combined with drivers' tendency to exceed the speed limit, presents a pedestrian safety issue. In May 2018, the Borough of State College approved an ordinance amendment that reduces the speed limit to 25 miles per hour along this stretch of Atherton.

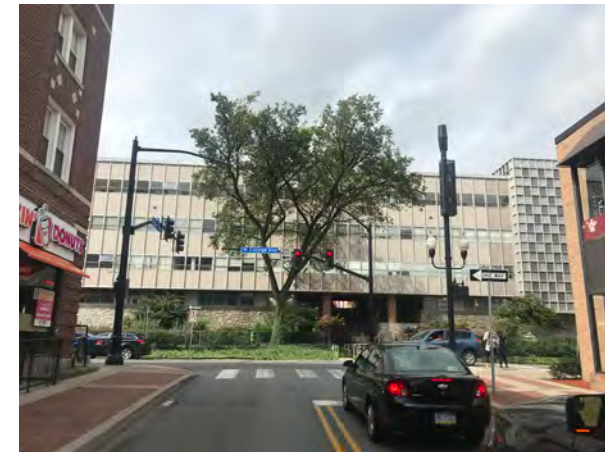
Below: Fraser Street and Hammond Building, Showing Breezeway Connection to Core Campus

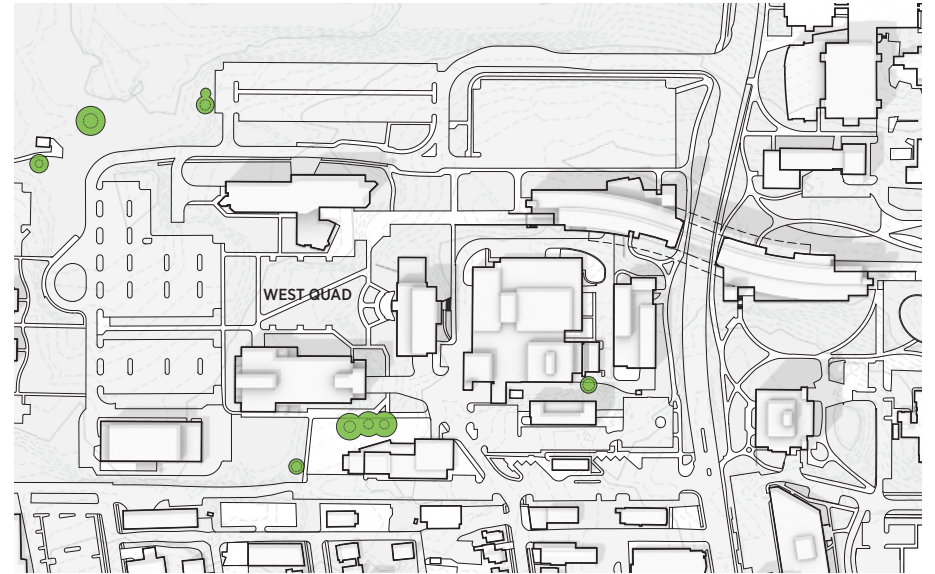
Protected Trees on West Campus' Area of Study

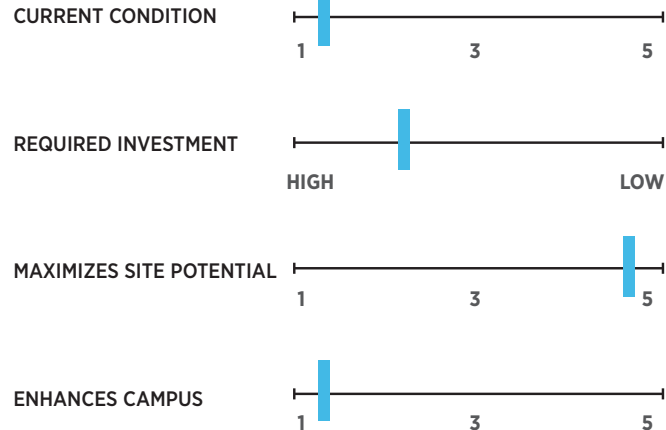
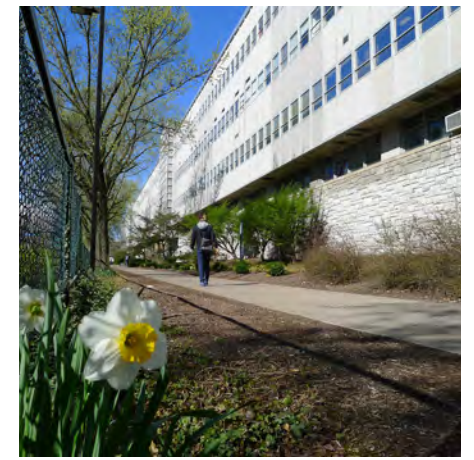
South Wall of Hammond at College Avenue

Building Envelope: The Hammond building utilizes a single-glazed, aluminum-frame curtainwall system with operable windows and fiberglass panels for the upper three floors, with a natural stone veneer base and end walls. The fiberglass panels are 1½” thick, suggesting a very low R-value. Glazing has a solar film that is compromised in many places, scratched and unsightly. The underside of the entry balconies is in poor condition, and the stone base needs re-pointing. The built-up roof is acceptable with no noted leaking.

and ceilings are stained and worn. Lighting is adequate. Bathroom finishes are original and merit replacement. Sealed, polished concrete floors have been patched and repaired in places. Presence of asbestos is suspected in the 9-inch vinyl floor tiles and in the curtainwall spandrel panels.

Code: The building does not have an automatic fire sprinkler system. The stair rise / run (7.25” × 11.25”) and the stair handrails and guardrails do not meet code. The plumbing fixture counts in the building may be inadequate.

Structure: The building’s structure consists of concrete framed superstructure with infill stack bond CME partition walls; concrete slab-on-grade at the basement; stone ballast on the roof. Level 3 omits the center columns and has a clear span utilizing steel bar joists. Lateral system likely relies on moment frame or infill masonry partition walls and shaft walls. Exterior concrete elements show some areas of extensive cracking, particularly at entry and exit areas, which likely have been exposed to chlorides and moisture. Interior corridor and basement level floor slabs also show cracking. Roof level is susceptible to vibration from typical walking level excitation due to longer slab spans.

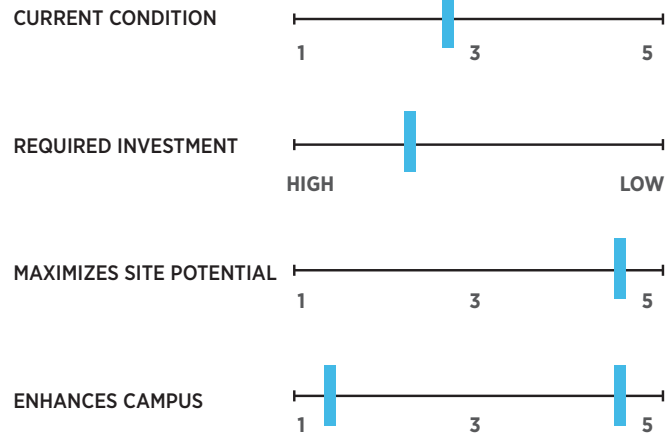
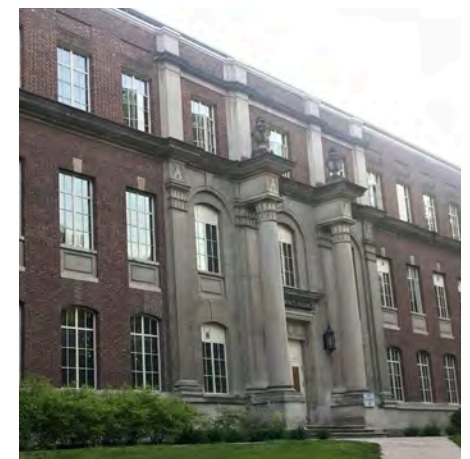
Original Sackett Façade Facing Old Main

Building Envelope: Sackett is a five-level building with brick veneer and a limestone base, with aluminum single-glazed windows that are likely 50 years old and in need of replacement. Exterior doors also need replacement. The roof is in good condition with no reported leaks. Brick is in good condition with some areas of cracking and some need for re-pointing. Limestone is deteriorating in some areas, particularly at the areaway on the west side. The building's main entry stair needs attention to cracking and railing replacement. The original slate-clad hip roof was removed at some point in time and replaced with corrugated metal wall panels and operable windows, in effect raising the hip roof and reducing its slope to provide occupiable space on the top floor.

Structure: The building's structure consists of unit masonry and stone masonry bearing wall on the perimeter with concrete slab and beam floors and concrete slab-on-grade at basement floor. Original drawings suggest deep foundations in the tall portion of the basement, which was designed for a hydraulics lab. Columns are located on both sides of the corridor, and terracotta masonry is used to infill between columns. Columns are likely concrete or steel sections wrapped in concrete. Lateral system probably relies on perimeter and infill CMU walls. Steel roof framing has been renovated with an enlarged envelope, exposing the original sloped steel framing. Exterior masonry shows minor weathering and wear.

Fire Protection: The building is not equipped with an automatic fire sprinkler system. A standpipe system (not NFPA) is fed from the incoming 6" domestic main in the mechanical room and serves what appear to be 2" standpipes that rise in the central corridor to serve 1½" valved connections at each floor. This system does not serve the roof, and no Fire Department connections were observed on the exterior.

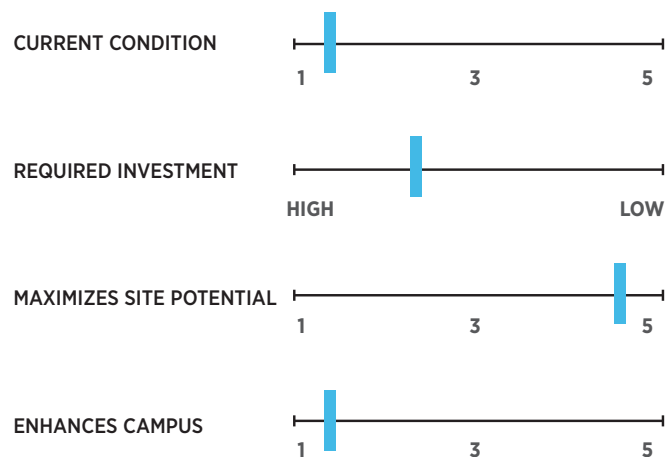
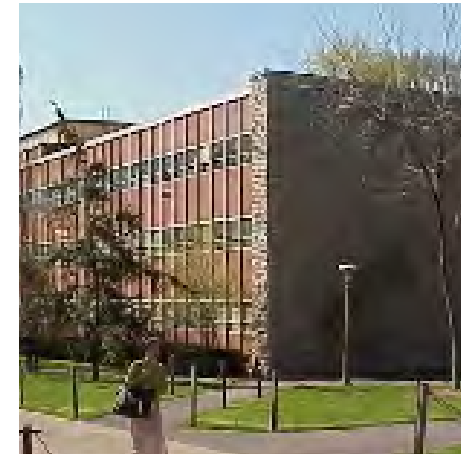
North Addition to Sackett

Building Envelope: The 1958 additions to Sackett (North Wing, South Wing, and Kunkle Lounge) were implemented as part of the Hammond project and are in the same architectural design. These additions utilize a single-glazed, aluminum-frame curtainwall system with operable windows and fiberglass panels for the upper three floors, with a natural stone veneer base and end walls. The fiberglass panels are approximately 1½” thick, suggesting a very low R-value. Glazing has a solar film that is compromised in many places, scratched and unsightly. The built-up roof has had some reported leaking.

Interior Finishes: The general condition of the finishes is in fair to poor condition. The paint in the building is adequate. Lighting needs replacement. Carpet and ceilings are stained and worn. Bathroom finishes are original and merit replacement. Sealed, polished concrete floors have been patched and repaired in places. Presence of asbestos is suspected in 9-inch vinyl floor tiles and curtainwall spandrel panels.

Code: The building does not have an automatic fire sprinkler system. The stair rise / run (7.25” and 11.25”) do not meet current code, and stair handrails and guardrails are non-compliant. The plumbing fixture counts are likely inadequate.

Structure: The building’s structure consists of steel and concrete frames, with a hung steel mezzanine at the Kunkle Lounge; and concrete slab-on-grade at the basement level. Lateral system likely relies on concrete or steel moment frames or shaft shear walls. Condition of interior superstructure is largely hidden by finishes and difficult to ascertain. Limited areas of exposed concrete structure at the mechanical room and along exterior overhang do not exhibit significant cracking.

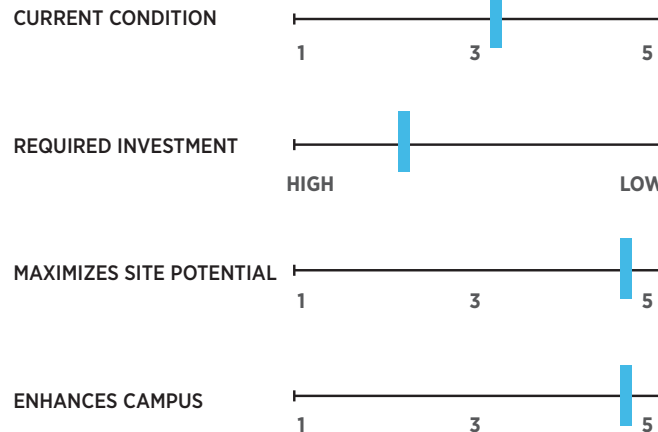
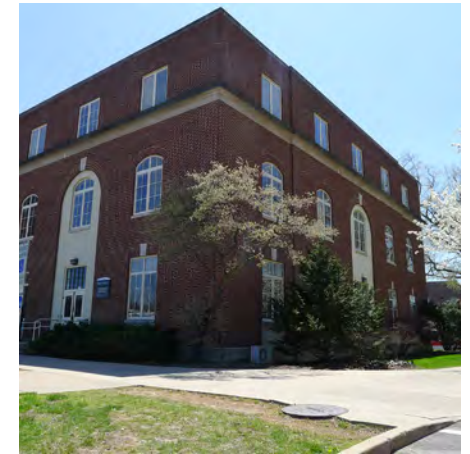
Northeast Exterior Corner of Reber

Building Envelope: Reber is a 4-story masonry building that has had two major additions in 1949 and 1993. The brick and limestone masonry are in good condition, with some minor re-pointing, re-caulking, and repair needed. The windows are aluminum-framed, operable, and double-glazed, installed in 1993 and in good condition with the exception of rusting over many of the lintels. The roof is in adequate condition with evidence of ponding and deterioration.

Code: The building is equipped with an automatic fire sprinkler system. The stair rise / run (7" and 12") is code-compliant. However, stair handrails (28") and guardrails (38") are lower than current code standards, and at times the guardrails are missing. Elevators have a 4-foot wide opening.

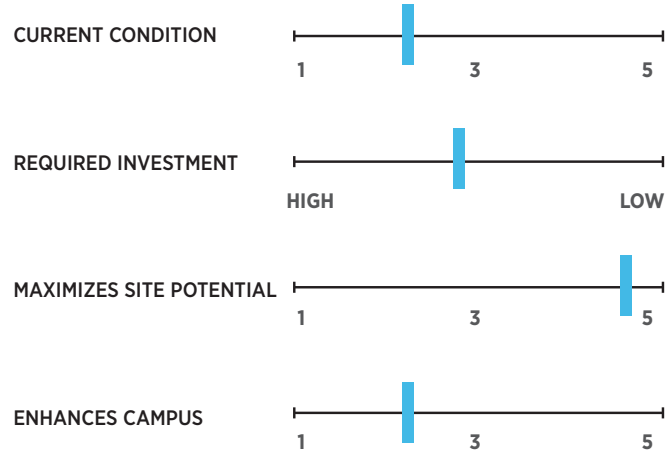
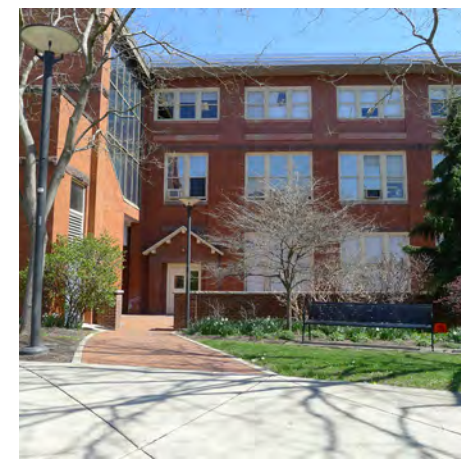
West Façade of the Units from Foundry Park

Building Envelope: The Engineering Units (A, B, and C) are an interconnected, 4-story masonry building in poor physical condition. Wood framed windows are single-glazed. Brick has deteriorated in many places and also needs repointing. There are visible cracks in the masonry at upper floors and some visible bulging. Exterior doors are a mix of replacement metal doors and original wood doors, which are in poor condition. There is a new roof on Unit C, and the other roofs are in adequate condition. The soffit and fascia at the cornice line appear to have been recently replaced.

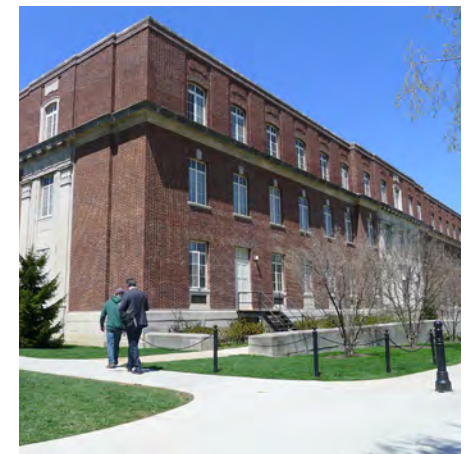
South Façade of Electrical Engineering West

Building Envelope: EE West is a 4-story masonry building with a full basement and partial 3rd floor. The building is red clay brick with a limestone and concrete base with classic ornamentation details. The brick is in good condition, with some need for repointing. The limestone base is stained in places. The windows are double-glazed with steel frames and internal blinds (installed 1980). The entrances have replacement doors, but in other areas the exterior doors need replacement. The roof is in poor condition with evidence of ponding and reports of leaking.

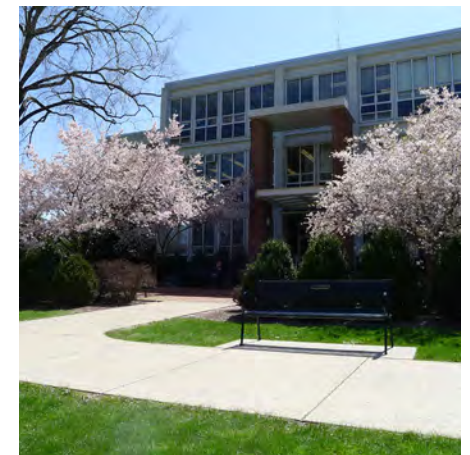
Entrance to EE East

Building Envelope: EE East is a 4-story concrete frame and brick infill building with aluminum curtainwall and windows. The concrete and masonry are in good condition, with some repointing needed. The curtainwall and windows are original and single glazed; the exterior doors need replacement. The roof is in good condition.

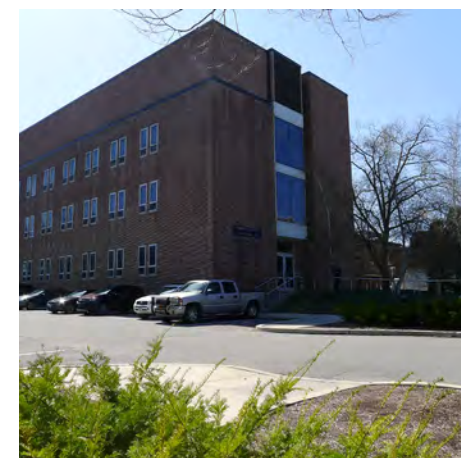
Southeast Corner of Hallowell

Building Envelope: Hallowell is a 5-story masonry building with some areas of curtainwall, but predominantly punched openings. The curtainwall and windows are double-glazed with an operable sash at the bottom. The brick veneer and mortar are in good condition. The high roof and low roof are in very good condition with no sign of ponding or leaking. There is evidence and reports of leaks on the north façade. The exterior doors are in good condition.

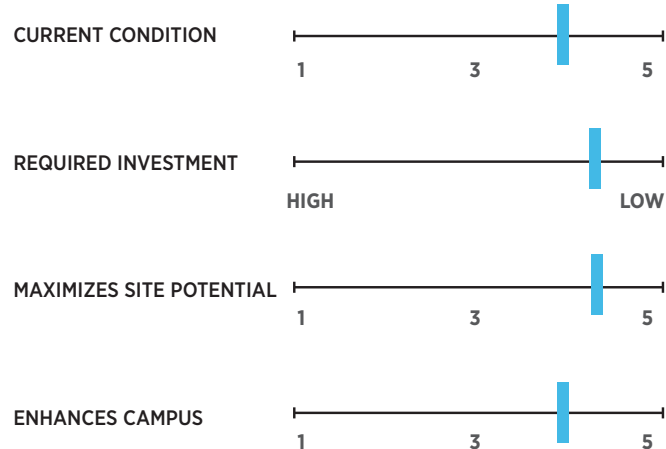
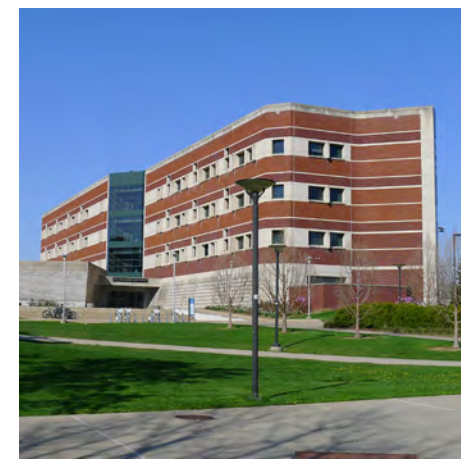
Southeast Corner of EES

Building Envelope: EES is a 4-story (plus basement) masonry building with predominantly punched openings with some areas of curtainwall. The building is veneer brick with precast concrete details and a granite base. There are sloped masonry walls at the base of the structure—in some cases these walls are solid, in other cases they are designed as a brise-soleil. The masonry is generally in good condition with some staining on the precast. Windows are double-glazed, and exterior doors are in good condition. There are coiling doors on every level to allow large equipment to be craned into the building, though the University reports that these are rarely, if ever, used. The roof is in adequate condition. Some locations of sealant on the granite base are failing.

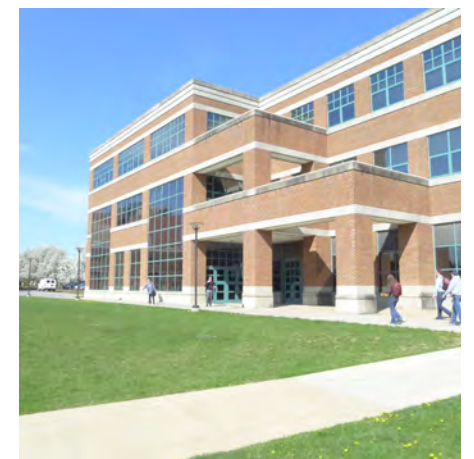
Exterior of Leonhard

Building Envelope: The Leonhard Building is a 3-story brick and cast stone masonry veneer building with a large roof skylight over a 3-story high bay / atrium. The roof is in adequate condition with some signs of ponding and some visible deterioration of the membrane. The brick, precast, mortar, and sealant are in good condition. The aluminum framed windows are double-glazed and are in good condition. Some windows are operable. Exterior doors are a combination of aluminum storefront, flush metal, and coiling overhead doors. All appear to be in good to excellent condition. There is a zone of the building on the 2nd floor with a raised access floor that would need to be addressed if the space is converted to wet labs.

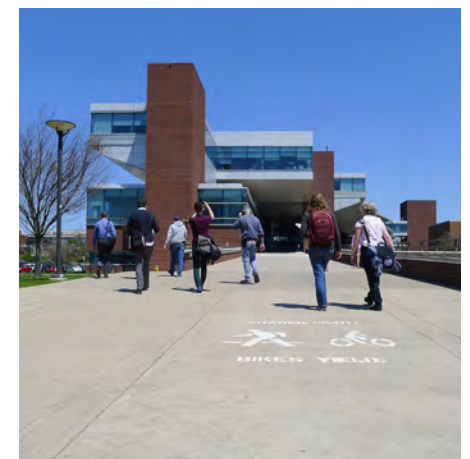
Entrance to Westgate from the West Campus

Building Envelope: Westgate is a 3-story masonry building that serves as a pedestrian bridge across North Atherton Street. The brick veneer is in good condition, as is the metal panel, curtainwall, and skylights. The single-ply membrane roof is in good condition but shows some signs of ponding and deterioration. There is minor damage to some of the curtainwall fins at the entries. There are some filled cracks on the pedestrian bridge that show evidence of leaking and repairs. The building is double-glazed. The entry doors to the building are in good condition.

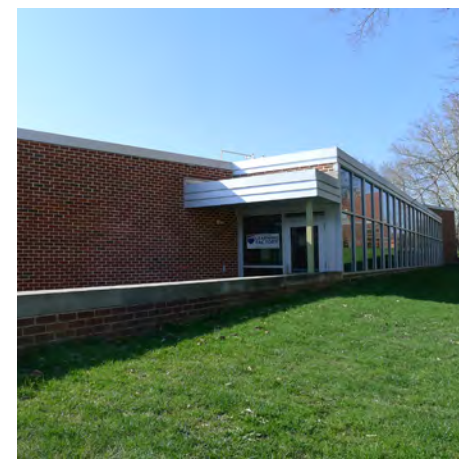
Entrance to Engineering Services

Building Envelope: Engineering Services is a one-story masonry building with brick veneer. The brick is in acceptable condition with some areas requiring repointing and re-caulking and many areas needing power washing. The roof is in good condition with no visible ponding. Some areas of moss were observed on the high ballasted roof.

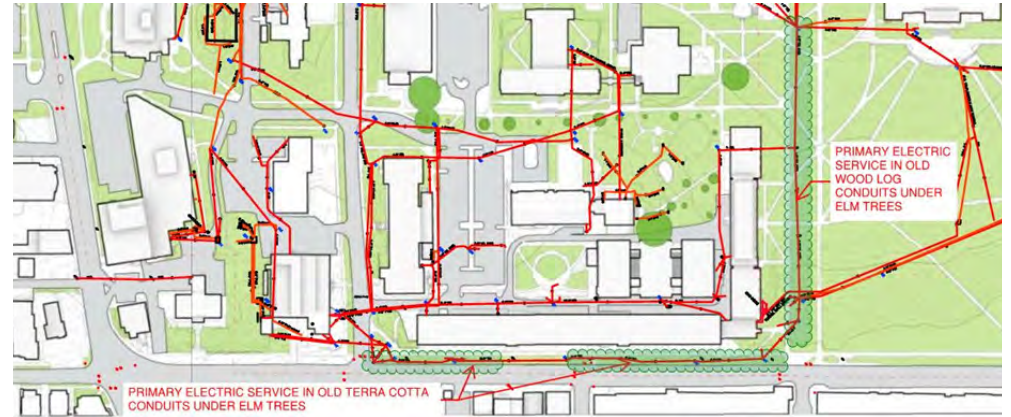
Core Campus Power Distribution

No load information has been provided regarding the spare capacity on the generators; however it is likely that upgrades will be required to support the proposed load of the new buildings. No detailed information was provided for the existing emergency power distribution throughout campus, so the capacity of these feeders should also be evaluated to determine any upgrades that will be required to accommodate the proposed program.

Optional Stand-by Power: A stand-by circuit provides power to serve critical research and legally required non-life safety backup power. This circuit will need to be extended to any buildings which require optional standby power.

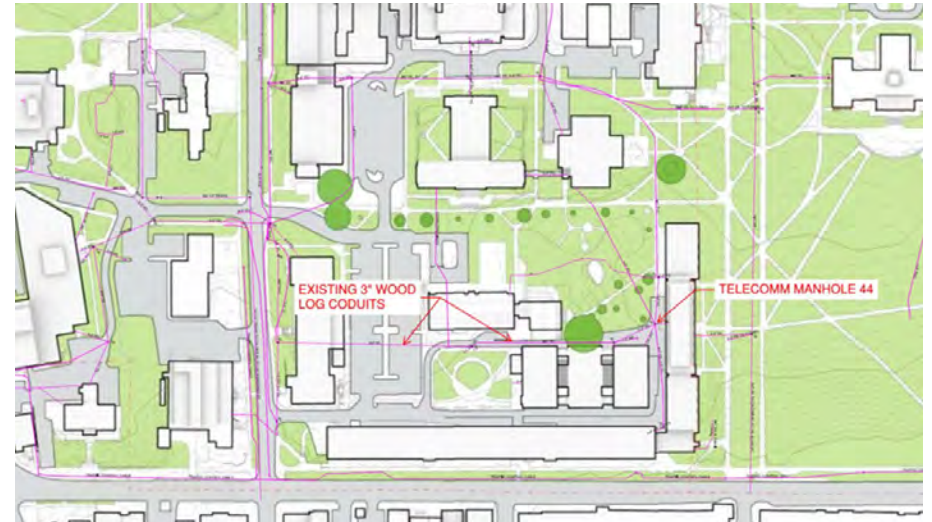
Core Campus Tel/Com Distribution

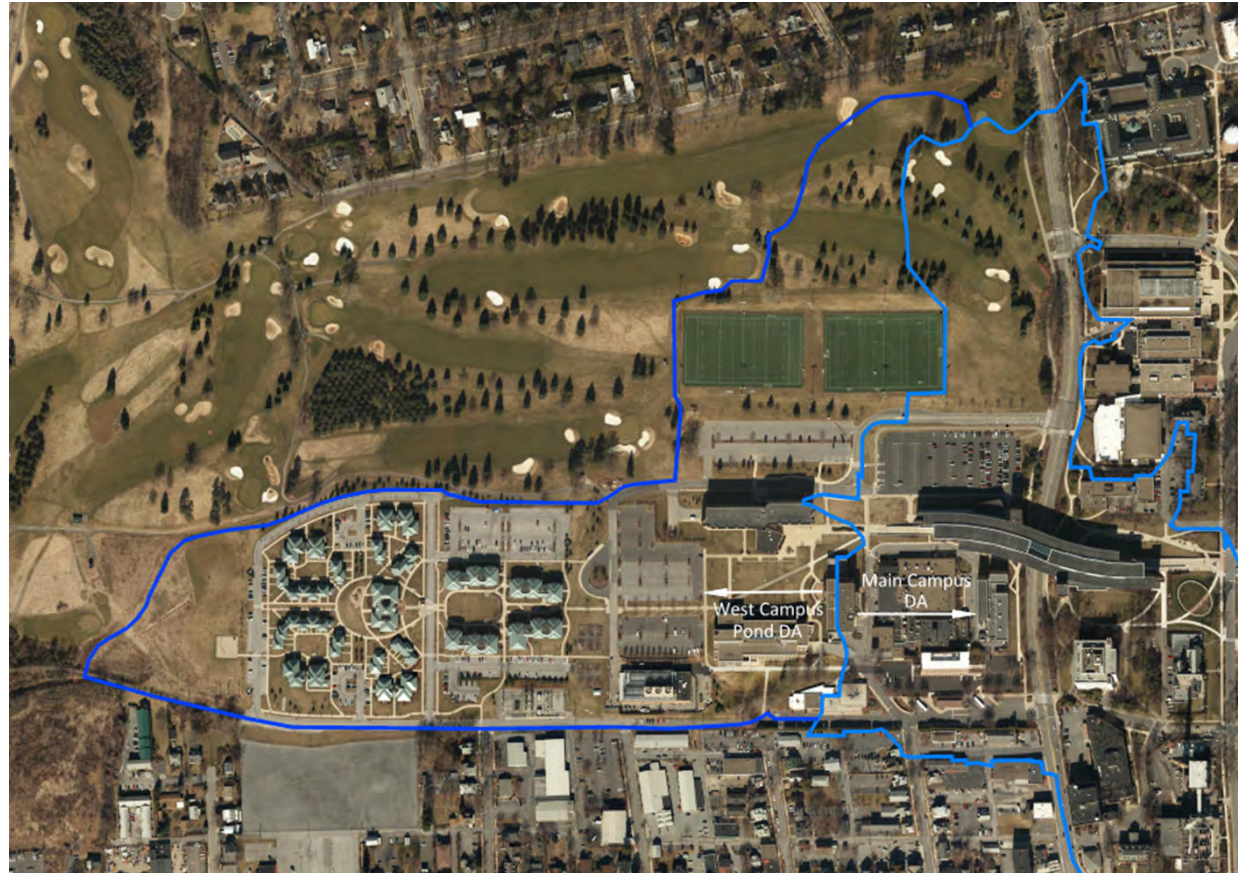
West Campus Drainage Divide Diagram (DA= Drainage Area)

Management: Land development and the construction of new impervious areas will trigger the need to install stormwater management controls to address peak rate, volume, and water quality regulations according to the Spring Creek Act 167 Plan, State College Borough Stormwater Ordinance, Ferguson Township Stormwater Ordinance, and PA Code Title 25, Chapter 102. Projects on Campus must also address policies in the University's document: *Penn State, University Park Campus, Stormwater Guidance, Policies, and Master Plan, December 2016* (Penn State Stormwater Master Plan).

Infiltration Regulations: The University Park Campus is located in the Ridge and Valley Physiographic Region and is underlain by highly fractured limestone bedrock. Sinkhole formation is common in the karst topography of the Nittany Valley. It is University policy to not use infiltration to meet volume control regulations in the vicinity of buildings and infrastructure. Vegetated Best Management Practices, such as rain gardens, can be used to address peak rate and water quality, but they must be lined and used for infiltration.
